Case Study: Structural Evaluation of Heavy Wood Trusses at Corpus Christi Army Depot, Texas

by Ghassan K. Al-Chaar, Dexter S. Yoon, and Pramod Desai

REFERENCE: USACERL Technical Report 99/26, Case Study: Structural Evaluation of Heavy Wood Trusses at Corpus Christi Army Depot, Texas

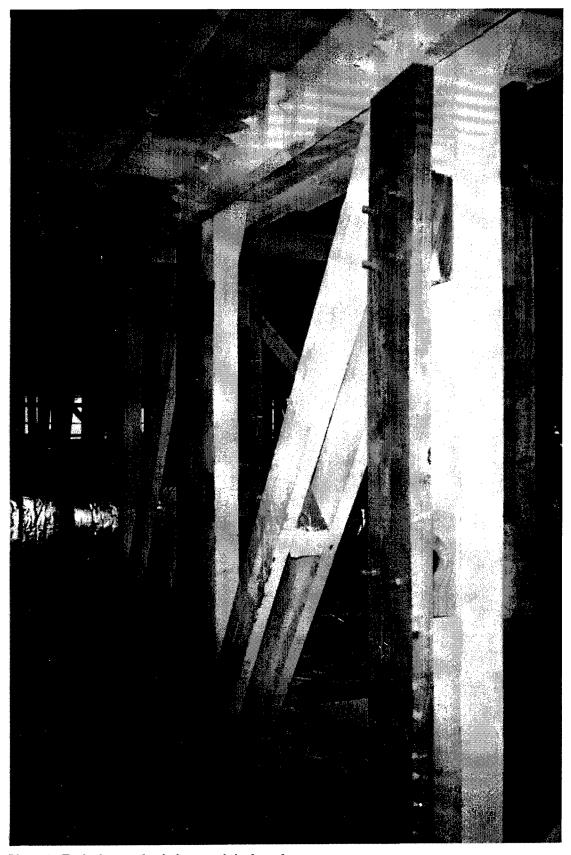
Photo 3. Typical type of existing repair in Area A.

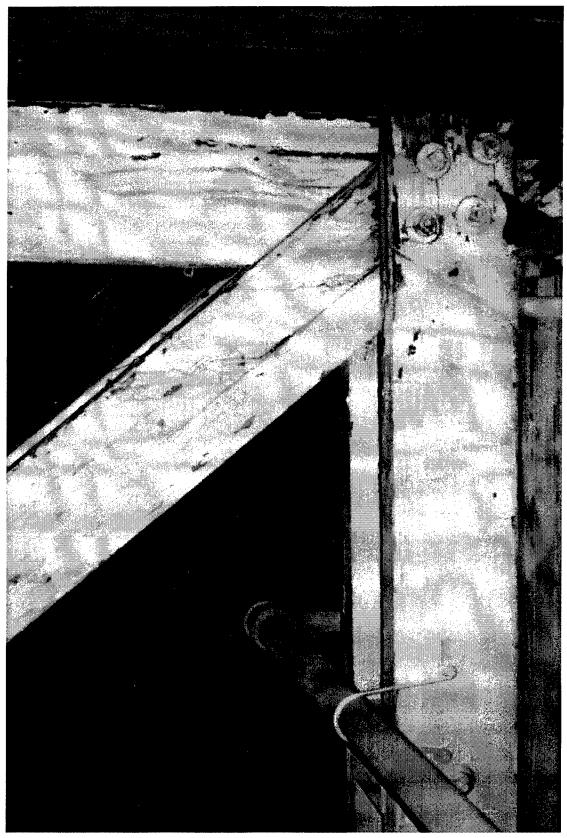
- 6. Decay was found in joint B, Truss 24.5. See Photo 9. The bolts are loose, and repairs are recommended in Chapter 6.
- 7. Eight diagonal members were found to be fractured, as shown in Photos 10 through 17. These members are: BZ and QM in Truss 27, CY in Truss 29.5, BZ and CY in Truss 34, DX in Truss 36, QM in Truss 36.5, and PN in Truss 38. See Chapter 6 for repair recommendations.

Photo 9. Major damage due to decay in a joint in Area A.

Item 6: The recommendation to repair Joint B in Truss 24.5 is presented in Figure I12.
